Events at Russian VVER NPPs

India, Kanyakumari, Tamil Nadu, 20th Annual Meeting of the Forum of the State Nuclear Safety Authorities of the Countries Operating VVER Reactors (VVER Regulators Forum)

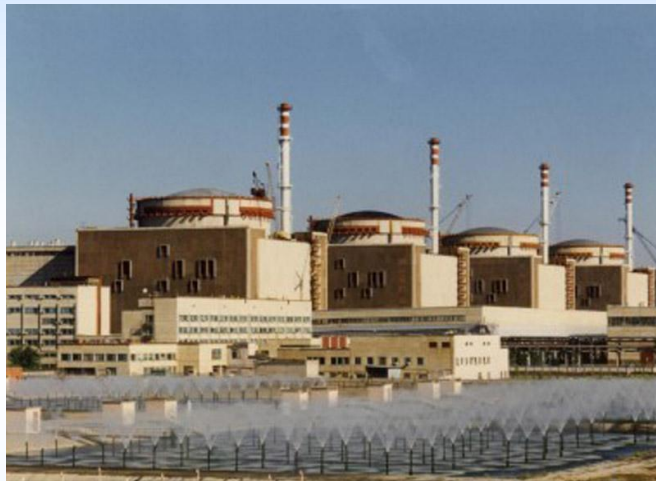
Operational Occurrence at Balakovo 4 (1/6)

Exceeding safe operation limits with the reactor scram by actuation of the reactor protection system caused by spontaneous opening and non-seating of the SG main safety valve due to erosive washout of the disk and seat of the pilot operated safety valve

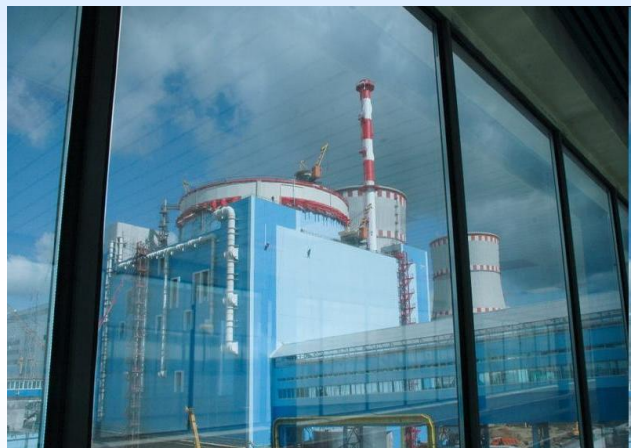
Operational Occurrence at Kalinin 4 (1/6)

Violation of safe operation conditions as a result of non-closure of the steam generator-2 main safety valve during the scheduled trial operation prior to the start-up of the unit due to the ingress of a mechanical particle (5x3 mm) under the seat of the steam generator-2 pilot operated safety valve.

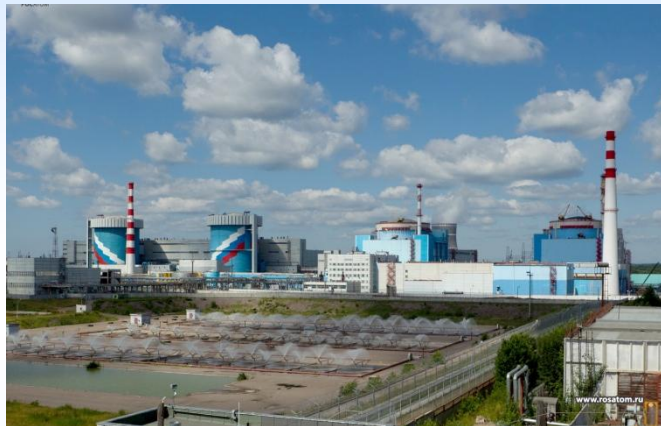
Operational Occurrence at Kalinin 3 (1/6)

Occurrence: Failure of the safety system trains due to non-opening of the main safety valve of the pressurizer PORV in the course of scheduled trial operation during the 2013 scheduled outage due to an insufficient steam flow rate from the head-end cavity of the main safety valve of the pressurizer PORV through the pilot valve as a result of non-conformance of the rated stroke of the slides of the pilot valve electric solenoids with requirements of design documents.
